# TECHNICAL SERVICE BULLETIN

## *Replacing the High Temperature Cutout on Built-in Wall Ovens (Service Kit 617877)*

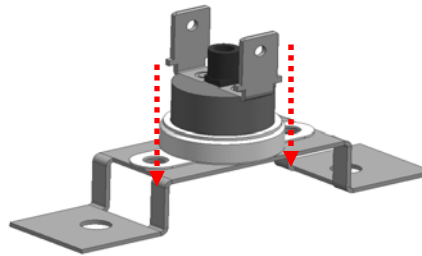
Mounting HTC to plenum

or

Mounting HTC to mounting bracket

In some double 27" built-in wall ovens produced prior to March 2009, the lower oven high temperature cutout (HTC) may trip prematurely. The transfer of excessive heat to the cutout from the screws which fasten the HTC to the plenum (or to the HTC mounting bracket) has been identified as the cause. If this occurs, replace the lower oven HTC and mounting screws with the new HTC and screws included in this service kit.

**TO ENSURE PROPER OPERATION, ALL PARTS IN THIS KIT MUST BE INSTALLED.**
